# PHENIX WEEKLY PLANNING

3/7/2013 Don Lynch

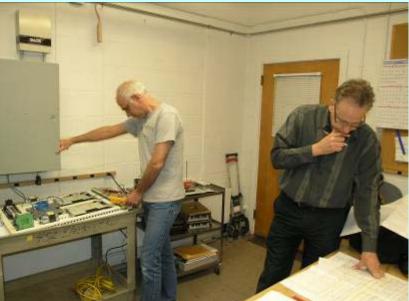
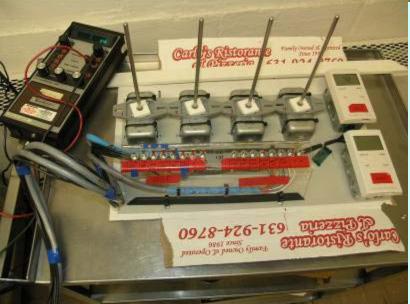
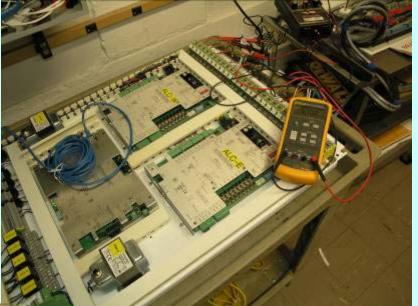
The two 10 ton units will have their Trane controls replaced with Automated Logic Corp. (ALC) controls.

Both units will be out of service during modification work for two weeks (in progress). Rack Room winter heat loads will be handled by the 30 ton and floor unit during this time.

Engineering work is in progress to eventually upgrade the 30 ton roof mounted unit controls and IR HVAC controls.

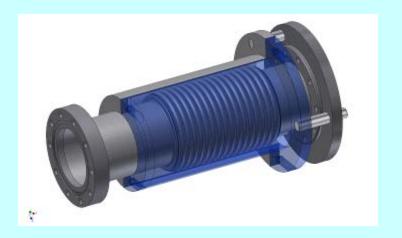
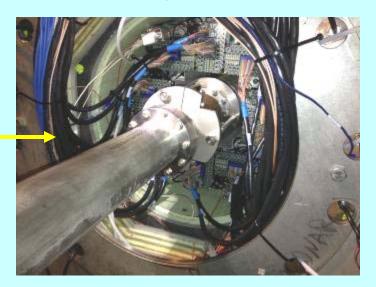
Proposed vacuum bellows anti-squirm
In MPC S Cavity to accommodate MPC-Ex

MPCS Flat cables replaced with round cables.
